Manhole Inspection Summary

Manhole # S29Q__022MH

Insp Date: **11/5/08 1:50 PM**

Location Address: **1204 Ridgely St**

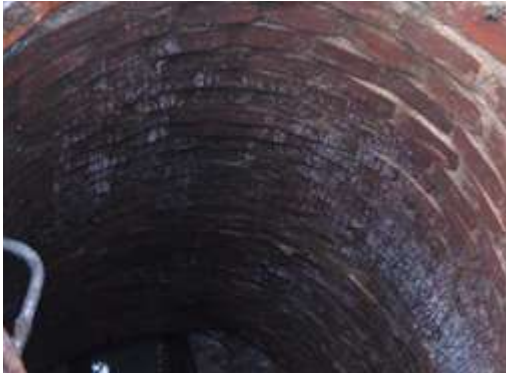
Defect 4

Infiltration: ☐ None ☐ Joint ☐ Cracks ☐ Mortar ☐ Roots ☒ **Wall**

infiltration at chimney & corbel walls

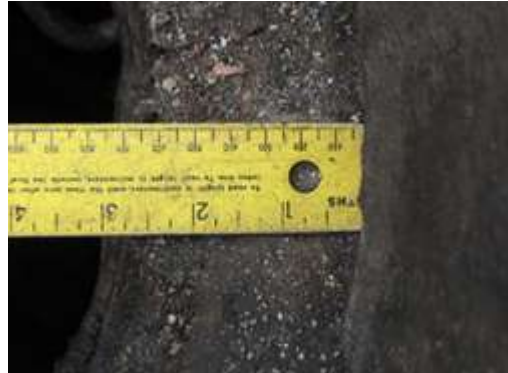
Defect 3

Frame Offset: **2.5** (in.) Condition: ☐ Sound ☐ Cracked ☒ **Leaks**

frame offset 2.5"

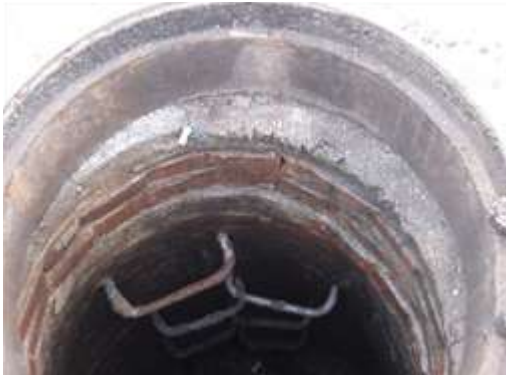
Defect 2

infiltration from frame

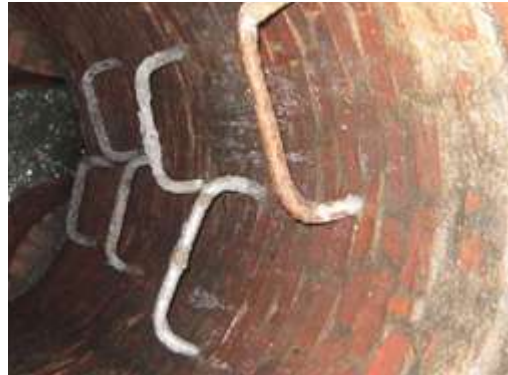
Defect 1

Steps Count: **6** Missing: **0** ☒ **Corroded**

corroded rungs

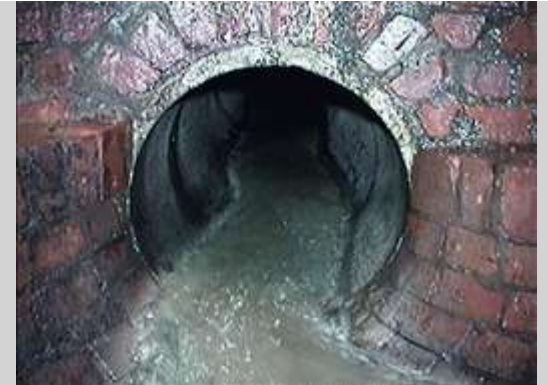
12 O'Clock Outflow

18 in. Circular Gravity Sewer
Pipe Out @ 12 O'Clock

Pipe Height: **18** (in.) Rod and Bar (Angled)
Pipe Material: **Clay** ☐ Pipe Lined
Invert Depth: **11.50** (ft.) Flow Characteristics: **Fast**
Deposits: ☒ None ☐ Mud ☐ Sludge ☐ Debris ☐ Grease
Silt Depth: **0** (in.) Deposits Extent:
Infiltration: **None** Pipe Seal Cond: **Sound**

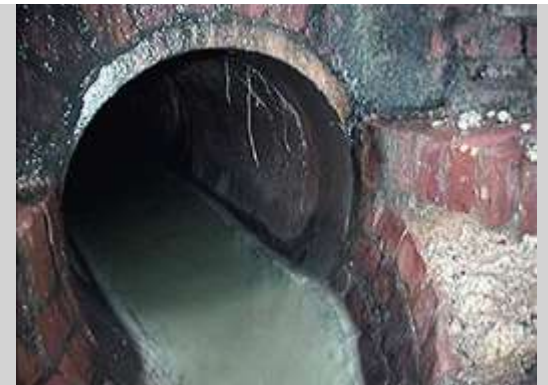
3 O'Clock Inflow

18 in. Circular Gravity Sewer
Pipe In @ 3 O'Clock

Pipe Height: **18** (in.) Rod and Bar (Angled)
Pipe Material: **Clay** ☐ Pipe Lined
Invert Depth: **11.28** (ft.) Flow Characteristics: **Fast**
Deposits: ☒ None ☐ Mud ☐ Sludge ☐ Debris ☐ Grease
Silt Depth: **0** (in.) Deposits Extent:
Infiltration: **None** Pipe Seal Cond: **Sound**

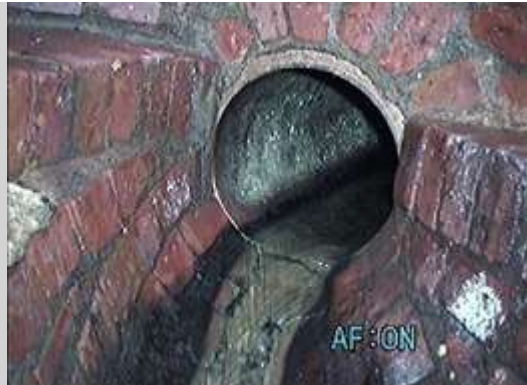
8 O'Clock Inflow

8 in. Circular Gravity Sewer

Pipe In @ 8 O'Clock

Pipe Height: **8.4** (in.) Rod and Bar (Angled)

Infiltration: **None** Pipe Seal Cond: **Sound**
